CONNECTICUT RIVER BASIN
MIDDLETOWN, CONNECTICUT
DOOLEY POND DAM
CT 00142

PHASE I INSPECTION REPORT
NATIONAL DAM INSPECTION PROGRAM

AUGUST 1980

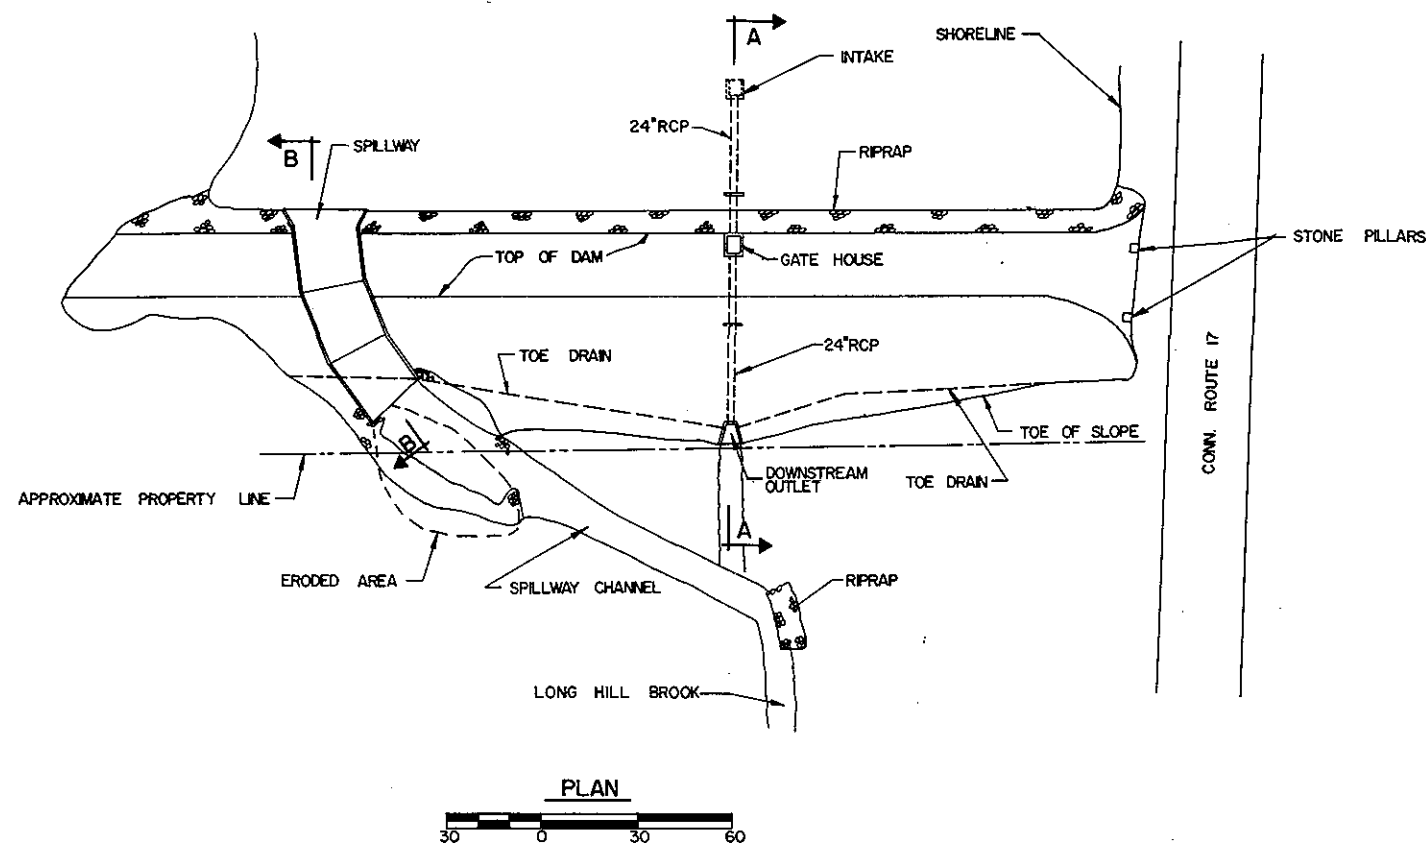
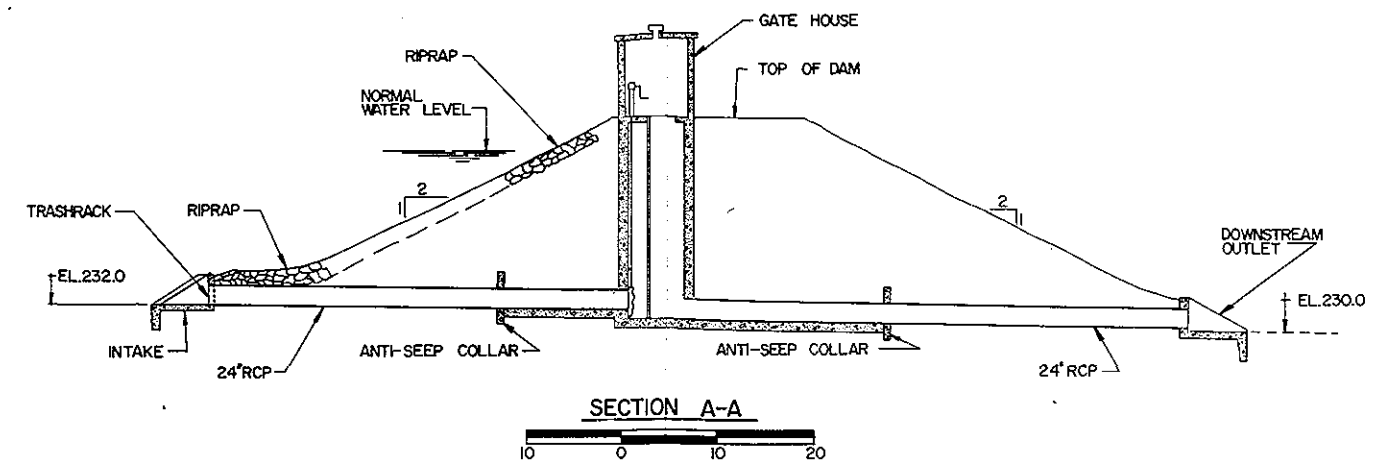
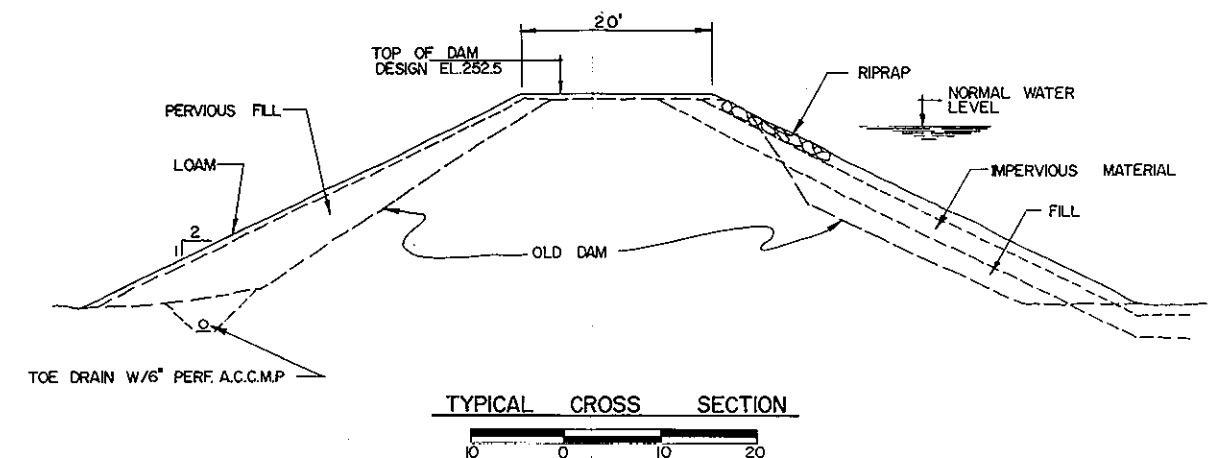
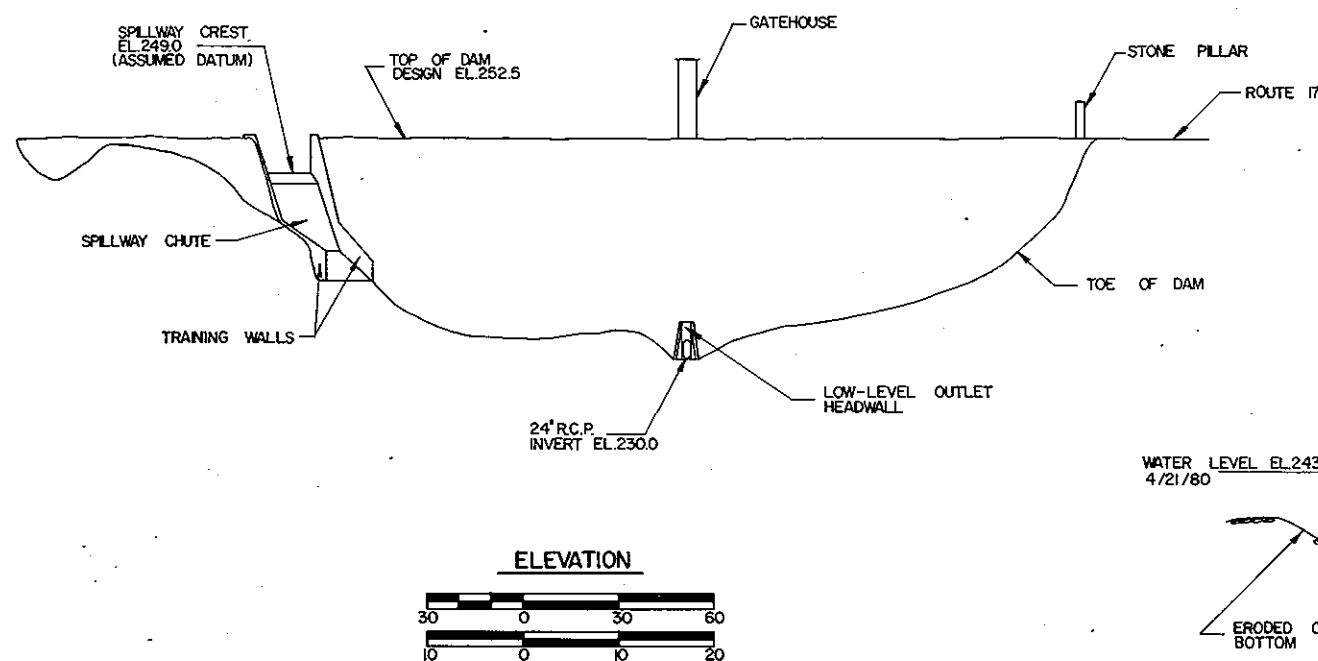
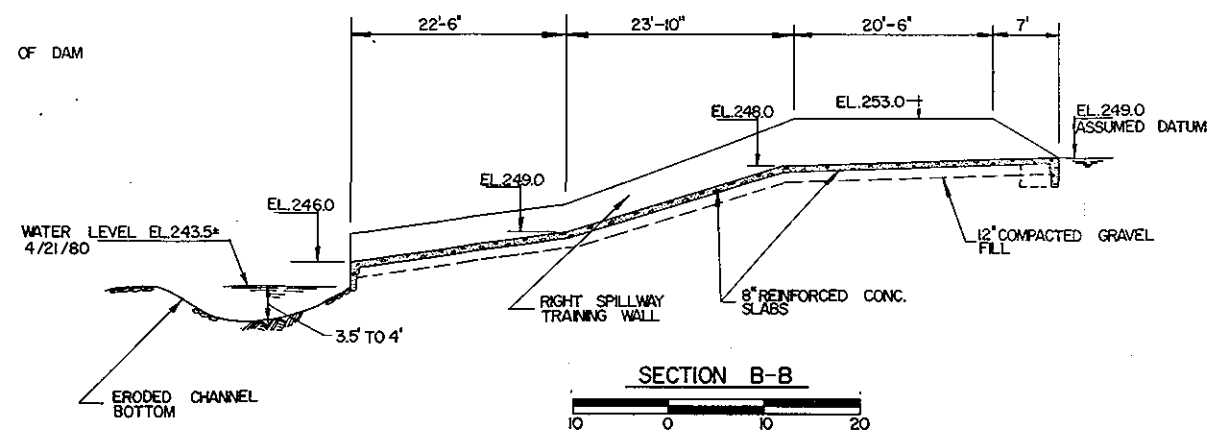
- NOTES:**
1. THIS PLAN WAS COMPILED FROM PLANS ENTITLED "REPAIR OF DOOLEY POND DAM" BY A.J. MACCHI ENGINEERS DATED APRIL 15, 1966. THE ERODED AREA AT THE TOE OF THE SPILLWAY IS SKETCHED IN PLAN AND SECTION ACCORDING TO OBSERVATIONS MADE BY CAHN ENGINEERS DURING THE INSPECTION OF THE DAM ON APRIL 21, 1980.
 2. THE WATER SURFACE ELEVATION OF 249.0 FOR THE POND SHOWN ON THE U.S.G.S MIDDLETOWN QUADRANGLE MAP WAS ASSUMED TO BE THE ELEVATION OF THE SPILLWAY CREST. ALL OTHER ELEVATIONS SHOWN ARE REFERENCED TO THIS ASSUMED DATUM, AS CONVERTED FROM THE EXISTING PLANS.
